CERTIFICATION OF CLOSURE

RIDGEFIELD BRICK AND TILE SITE

RIDGEFIELD, WASHINGTON

February 15, 1984

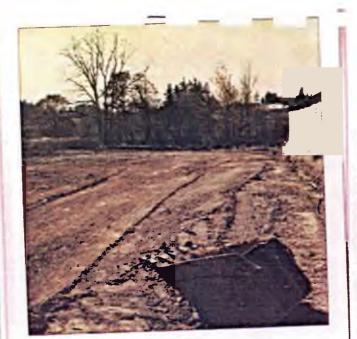
VENT DITCH
II' TO WASTE CONTACT
